*Brinelling on the swash plate bearing surface is common with Rexroth A4V and A11V pumps and Sundstrand 90 series pumps. We at Lapping Services answered the call for help from a number of our clients to repair these expensive components.*

**Finished!**

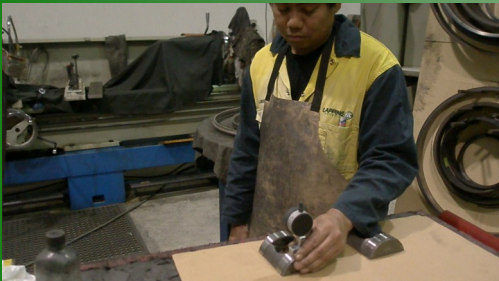
*Lapping Services' employee checking a 90series swash plate with our special measuring equipment*
